Flood Inundation Areas Surrounding Vijayawada, Andhra Pradesh

Charter Call 1036

AOI No.07

Based on the analysis of PLEIADES Satellite Image on 11.09.2024

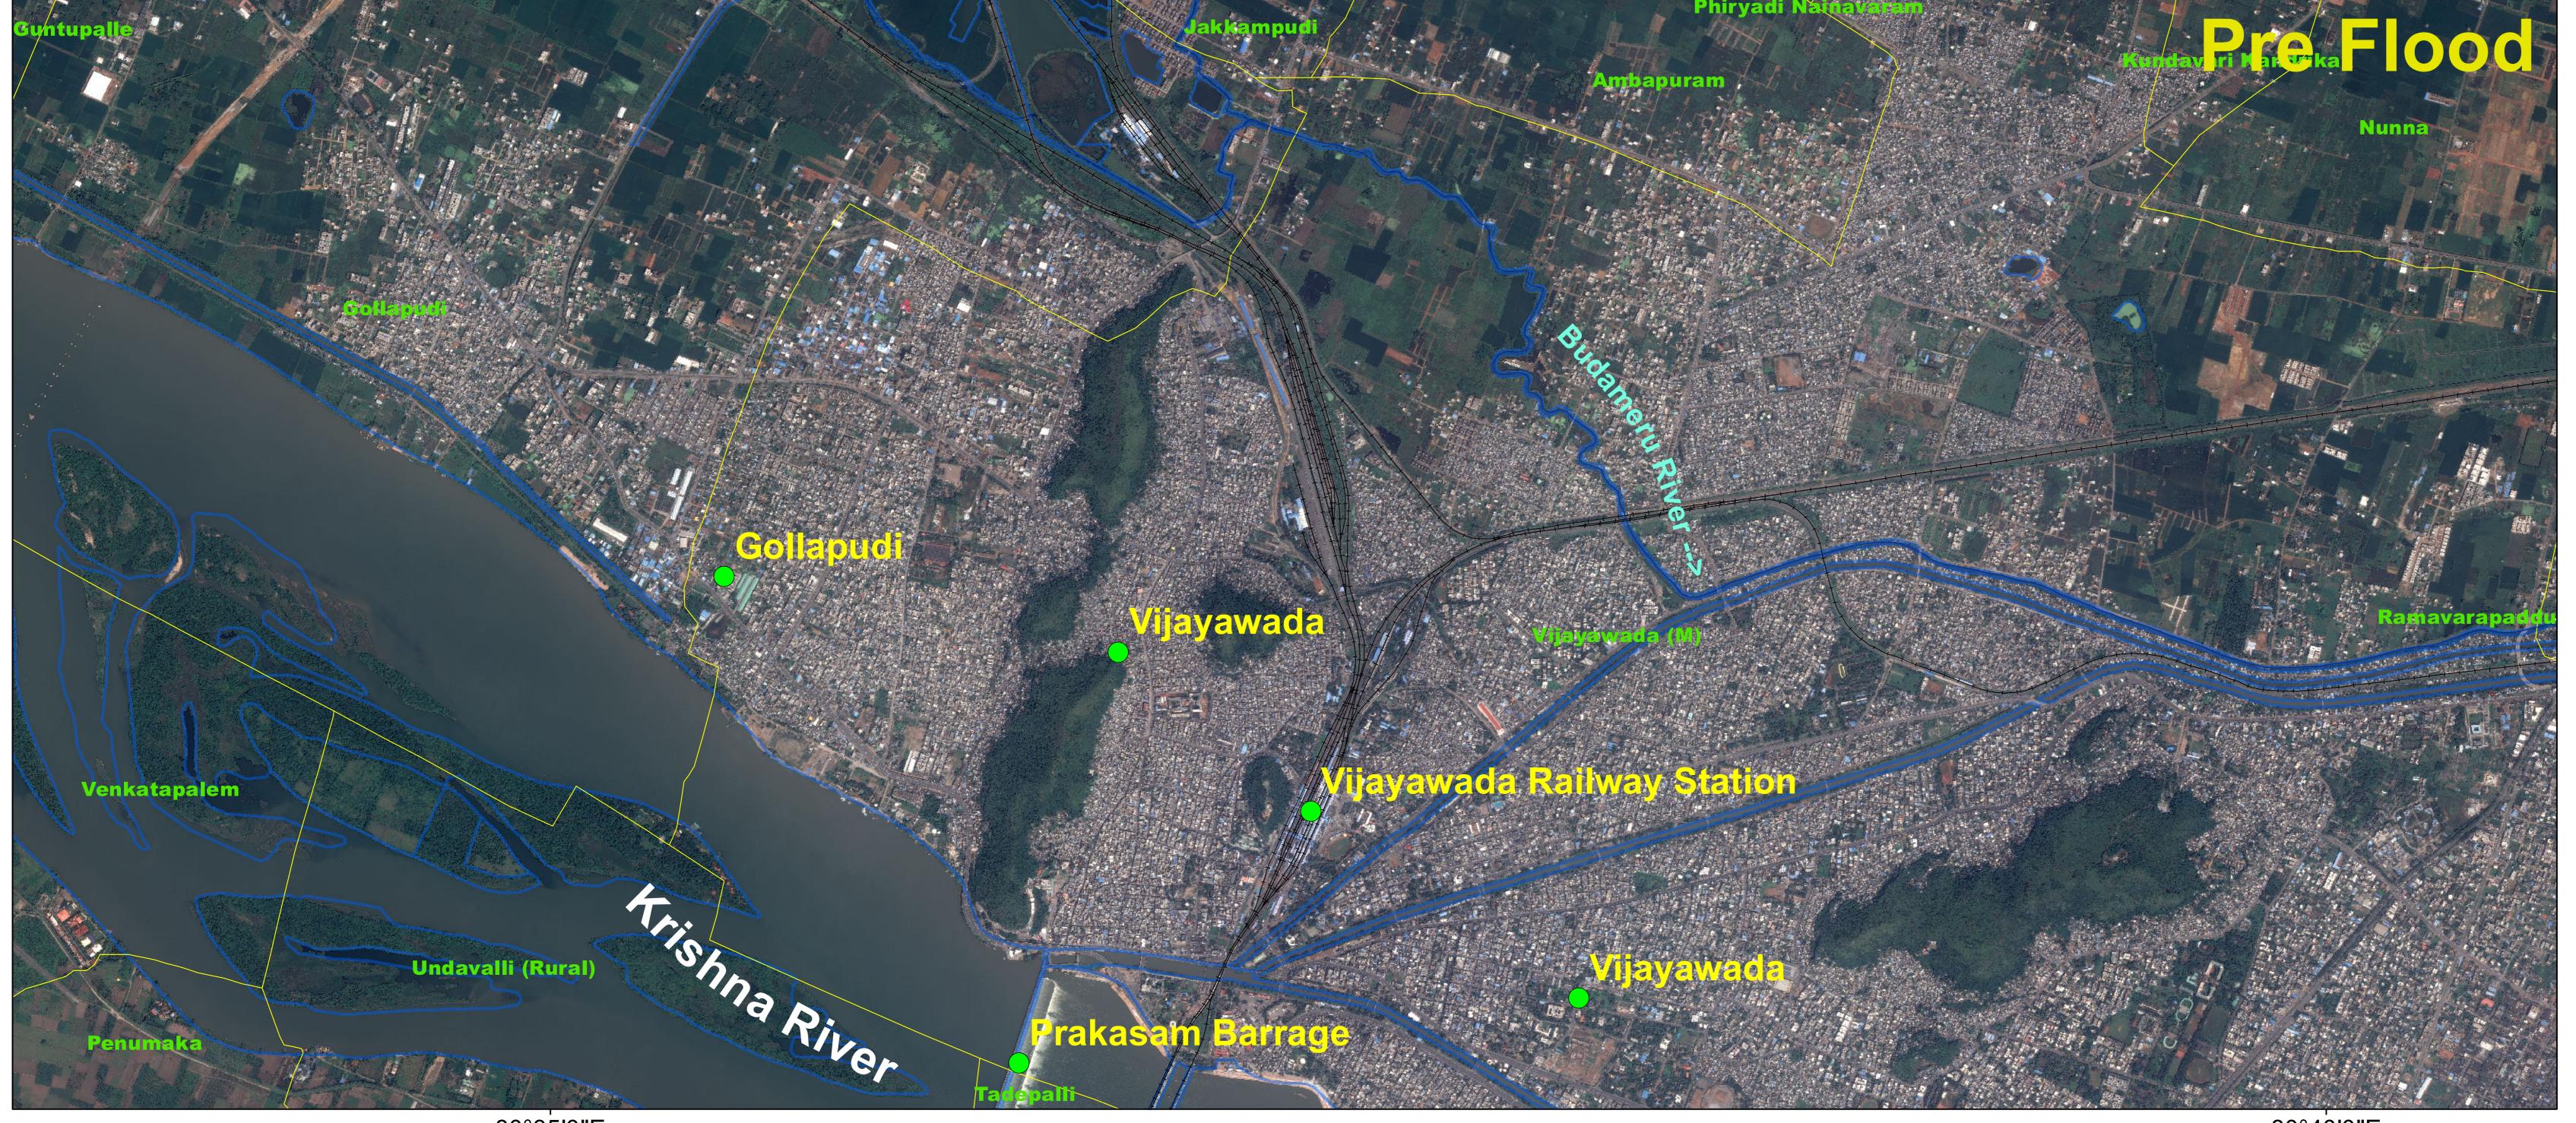
Heavy rains are witnessed in Andhra Pradesh and overflow is observed in Krishna River / Tributaries at Vijayawada. This map highlights the areas of flood inundation / Standing water after the heavy rains. Disclaimer: This Map is prepared on rapid mapping mode for immediate use and sharing amongst official agencies. This provides preliminary results. Flood inundation may include rain water accumulation / flood water in low lying areas.

Pre Event Image: PLEIADES, 22-Oct-2022 Post Event: PLEIADES, 11-Sep-2024
