# Vijayawada, Andhra Pradesh, India

Flood Inundation Areas Surrounding Vijayawada, Andhra Pradesh

Based on the analysis of RCM Satellite Image on 05.09.2024 (0600 Hrs IST)

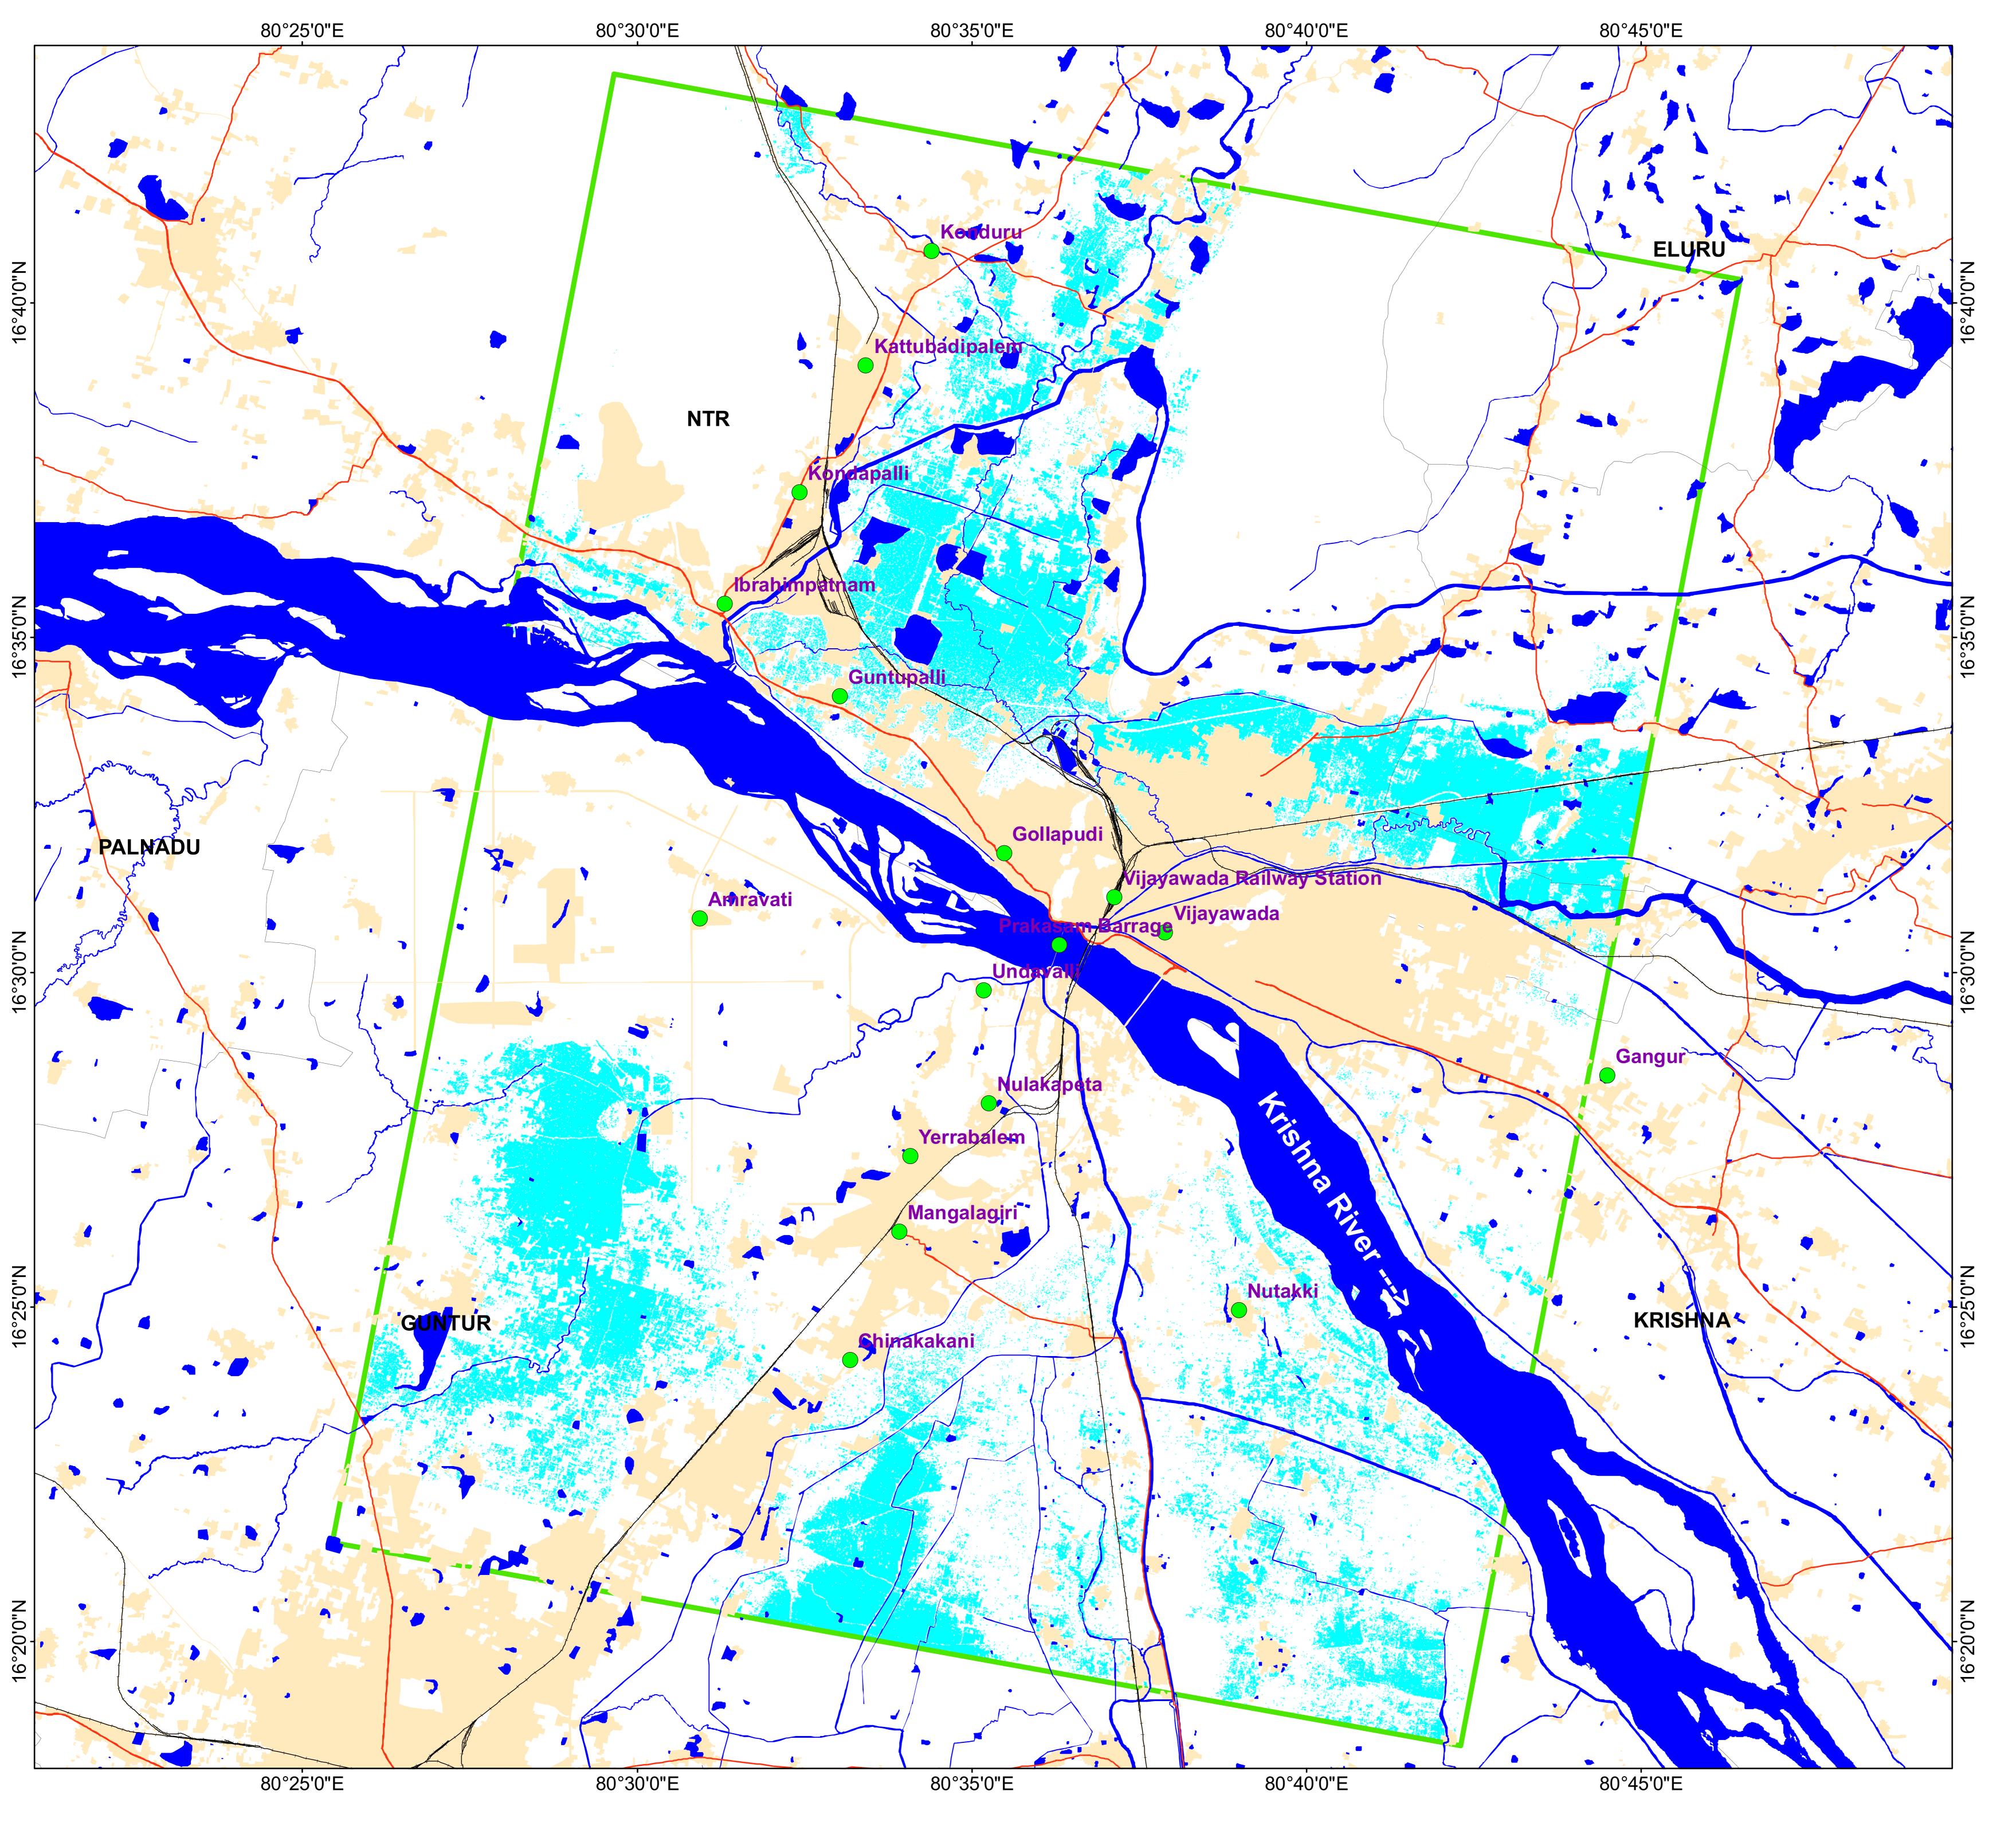
Heavy rains are witnessed in Andhra Pradesh and overflow is observed in Krishna River at Vijayawada. This map highlights the areas of flood inundation / Standing water after the heavy rains.

Disclaimer: This Map is prepared on rapid mapping mode for immediate use and sharing amongst official agencies. This provides preliminary results. Flood inundation may include rain water accumulation / flood water in low lying areas.

All geographic information has limitations due to the scale, resolution, date and interpretation of the original source materials. There are limitations for SAR data in detecting inundation in urban areas. No ground verification is done.

Pre Event Image : Sentinel-1A, 20-Aug-2024 Post Event : RCM, 5-Sep-2024
